Ada Township Parks & Recreation
7330 Thornapple River Drive
Ada, Michigan 40301
Site Accessibility Report

Prepared by Disability Advocates of Kent County

May 15, 2017

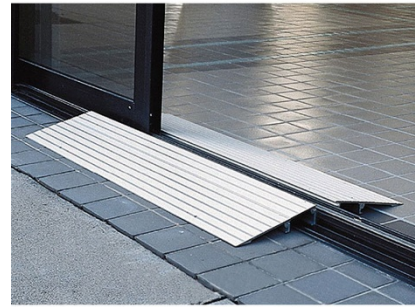
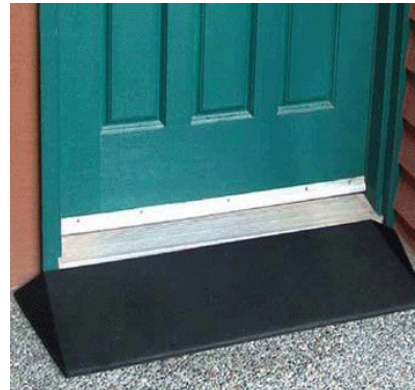
- **The Maintenance Building/Garage:** The Service Garage entrance threshold exceeds 1-inch. As the sole entrance to the structure, this element should have threshold that does not exceed ½-inch. This may

be accomplished using the same techniques presented above for the Ada Township Parks Office thresholds (**Level 2 recommendation**). The door at the entrance has a Knob-style handle. This may present a barrier to people with limited grip strength or manual dexterity from using the entrance. The door opening mechanism should be replaced with Lever-style handle, so as to enable the use of the door without twisting, grasping, or pinching (**Level 2 recommendation**).

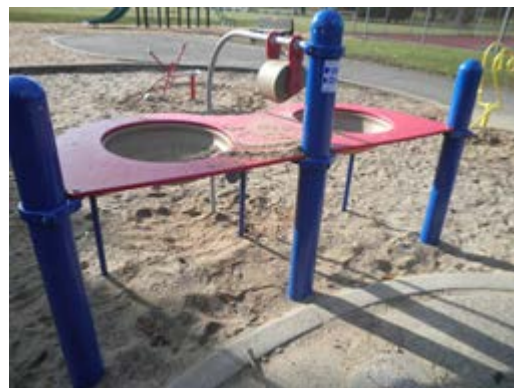
- **Playground:** The playground is surfaced with compacted wood chips. This is acceptable, as long as the wood chips are routinely maintained to ensure that the surface is level and stable. Currently, the wood chips are not well maintained. There are frequent divots, and significant mounding can be found along the accessible routes through the playground area. To make the playground accessible, the surface should be raked to ensure that play area is level, and new wood chips be brought in to fill in the divots and holes (**Level 2 recommendation**). Ideally, the wood chips would be replaced with a poured-in-place surface. In addition to providing a very firm and stable surface, the costs associated with maintaining an accessible wood chip play surface, including cost for labor and purchasing of materials, would no longer be required (**Level 3 recommendation**). The woodchip surface is accessed by a protruding-style curb ramp near the sand pit element. This type of curb ram is acceptable. However the ramp is not very well maintained. There is a 1-inch high transition at the top of the ramp. This may prevent guests from crossing over the transition and accessing the playground surface level. This transition should be

ground do to be flush with the ramp surface (**Level 2 recommendation**). In addition, the base of the ramp abuts the wood chip surface of the playground. Care should be taken to ensure that the wood chips are well maintained and provide a level and stable space at the bottom of the ramp (**Level 1 recommendation**). The main play structure is equipped with a paved accessible ramp. Currently, the sides of the paved ramp are not protected at the top of the ramp near the transition to the play structure. At its most extreme, there is a 12-inch drop off the sides of the ramp. This may present the risk of guests rolling or falling off the sides of the ramp. Making this ramp accessible may be accomplished by either constructing a curb along the sides of the paved ramp that is not less than 4-inches high (**Level 3 recommendation**), or continuing the turf and soil so as to be flush with the edge of the paved ramp up to the existing retaining wall (**Level 2 recommendation**). There is an accessible swing set on the east side of the playground. The safety bar on one of the swings is not able to be secured and needs to be repaired (**Level 2 recommendation**). The playground has a second play structure without an access ramp. This element has a transfer platform instead. The transfer platform is has a slope that exceeds a 6.2% grade. This presents a hazard for guests who may fall off the platform. The transfer platform should be repaired so that the slope in any direction does not exceed 2.0% (**Level 3 recommendation**). The only accessible routes to the playground wood chip surface level are via the curb ramp near the sand pit, and the curb ramp near Public Restroom and Shelter. This is acceptable under the ADA. However, there is a significant distance between the ramps and the play elements on the other side of the playground, including the accessible swing set. By adding a third curb ramp near the swing set, the overall accessibility of the playground would be greatly improved (**Level 3 recommendation**).

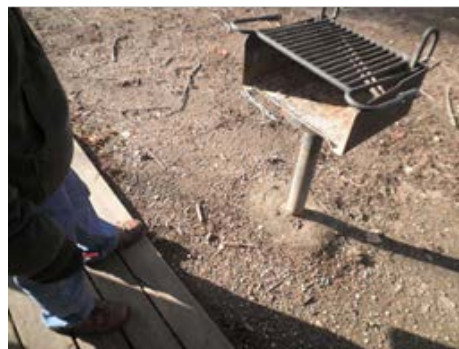
- **The E.E Locke Arboretum Gazebo & The Ponds Gazebo:** The Arboretum and Ponds Gazebo each have a grill station for guest's use. However the grill stations are located away from the stable and level surface of the Gazebo floor. The Gazebos are a main feature of the park and the adjacent grill should be made accessible. As the Gazebos are primarily wood, the grills cannot be moved to be directly adjacent to the structure. However a concrete or asphalt pad should be added that directly connects with the wooden floor of the Gazebo (**Level 3 recommendation**). The grill station cooking surface is over 36-inches above the ground. This may be a barrier to guests who use assistive technology such as wheelchairs or scooters, and who may not be able to use a cooking surface that is so far off the ground, or who are unable to safely use the station with the flame element so close to the face. The grill station cooking surface should be lowered so that it not higher than 36-inches above the ground (**Level 2 recommendation**).

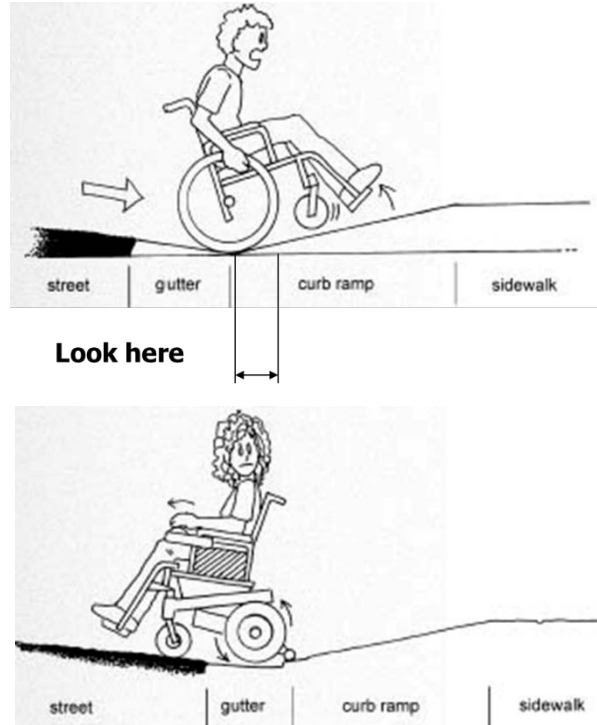
- The Parking Lot:** The parking lot is in excellent condition. However, the curb ramp located near the designated accessible parking spaces is a barrier. The ramp slope is ADA compliant. The Ramp-Gutter Transition, or the section of the ramp nearest the Gutter, is significantly steeper. This may make it difficult to impossible to use the ramp while using certain models of assistive technology. Requiring guests to use the curb ramps at the other ends of the parking lot is not acceptable. One way to

comply with the ADA is to move the accessible parking spaces to a different curb ramp. However, the current placement of accessible parking spaces is optimal, and allows for people with mobility related disabilities to exit a vehicle and be near to many different park attractions. By moving the parking spaces to different locations, the access to some features may be reduced due to increased distances. For instance, if the two spaces were moved towards the Ball Diamond Overlook, people with limited stamina or mobility would be discouraged from visiting the Covered Bridge and River Overlooks. Alternatively, by moving the accessible parking spaces to the curb ramp nearest the Covered Bridge, these same guests would be discouraged from visiting the Ball Diamond Overlook. To comply with the ADA, the current curb ramp near the designated parking spaces should be renovated to have a shallower ramp-gutter transition.

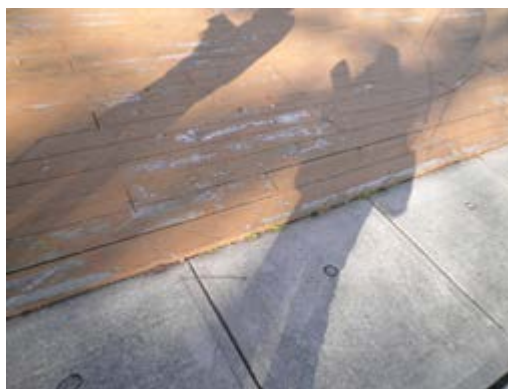
- **The River Overlook:** The threshold between the wood deck material and the concrete sidewalk shows extensive damage. The wood material exhibits significant changes in level and fracturing that exceeds 1-inch. In addition, significant erosion is evident, as the entire overlook is settling and sloping down towards the river edge. The high threshold may make it difficult to impossible for guests with assistive technology such as wheelchairs, scooters, and walkers to use the overlook. Making this space accessible and compliant with the ADA is difficult and the repairs may be costly. The Overlook floor should have a slope that does not exceed 2% grade in any direction. This may be difficult as the foundations will need to be repaired (**Level 3 recommendation**). The exact method for how this is accomplished goes beyond the scope of this audit. The threshold between the concrete path and the wood floor of the Overlook should be repaired so that any changes in level does not exceed ¼-inch. This can be accomplished by either beveling the surface of the wood down so as to be flush with the concrete. If it is not feasible to apply this treatment to the entire length of the Overlook, a section that measures not less than 36-inches wide should be placed nearest the parking lot and should be indicated. This indication may be colored or textured tape on the edge of the beveled section of the

wood floor. While 36-inches is permitted as the minimum wide under the ADA, it is recommended that the width of the beveled section be not less than 60-inches (**Level 2 recommendation**).

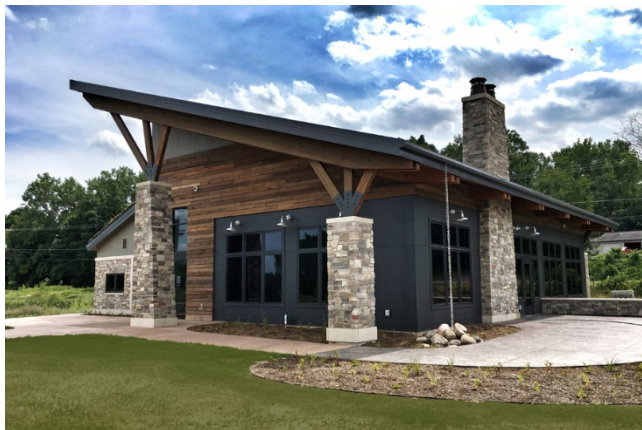
- **The Resource Center:** There are two entrances to the building. The Main Entrance door requires 7-pounds of force to open. While the ADA does not place a limit to the amount of force required to open an *Exterior* door, the weight of the door may be a barrier for people with

limited strength or mobility. Making the door easier to operate may be accomplished in a couple of ways. The ideal option is for the entrance to be outfitted to open by a powered door. However, as installing a powered door is a significant investment this

may not be feasible in the near future. The other option is for the Main Entrance Door door-closer mechanism be re-tuned to require less force to open. The hydraulic device at the top of the door may be readjusted to make the door require not more than 5-pounds of force to open (**Level 1 recommendation**). 5-pounds of force is the standard limit for interior doors, and is supported by the ADA as being an operable door weight for people with limited stamina or strength. The Patio Entrance requires 6-pounds of force to open. If the Main Entrance Door is readjusted, the Patio Door does not need to be. Ideally though, the door closer mechanism may be re-tuned to require no more than 5-pounds of force to open (**Level 1 recommendation**). The Banquet Hall¹ Double-doors off the main hall require 8.6-pounds of force to open. This is a significant weight and is a barrier to people with limited strength and stamina. In order to make this means of egress into a main feature of Resource Center accessible, the door closing mechanism should be readjusted to require no more than 5-pounds of force to open (**Level 1 recommendation**). The Banquet Hall has two Climate Control panels. One of the panels has operable

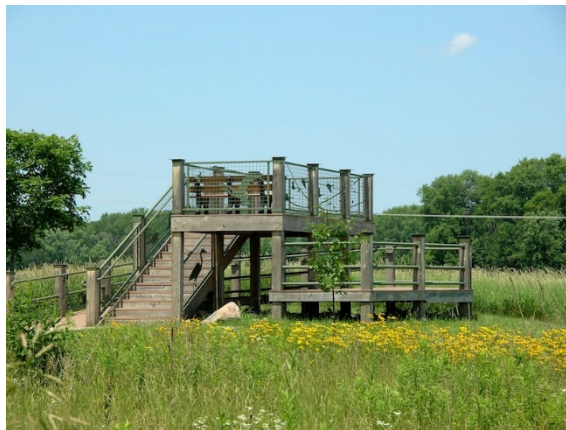
- **Roselle Park Trails:** The Woodrick Memorial Wildlife Observation Deck is a wood bi-level platform with a ramp to the upper level. The upper level has a bench, while the lower level does not. While there is ample room on the lower level for assistive technology such as wheelchairs and scooters, people who do not use these devices yet may not have the strength or stamina to stand for extended periods of time will be required to climb stairs to find a place to sit. In addition, ambulatory guests may wish to observe the surrounding grounds with their friends or family who require the use of assistive technology and have no seating options on the lower level. To make this space equally usable for people regardless of ability, there should be a bench on the lower level of the observation deck (**Level 2 recommendation**). The Elevated Wetlands Observation Deck has a gently sloped wooden deck path up from the paved trail. The slope is shallow enough to not be considered a ramp. There is edge protection along both sides of the deck path. However the edge protection is not present on Northwest side of the observation platform by the seats. Edge protection prevents devices from rolling over the sides of an element, and provides warning that a drop-off is beyond that point. In order to make this space comply with the ADA, the edge protection should be continued along the Northwest side of the observation platform (**Level 2 recommendation**). The Barrier-Free River Overlook is accessed by a paved path. However, the path is sharply narrows towards the threshold of the Deck. The complication is very similar to what is encountered at Ada Township Park the Ponds Bridges. There is a sharp drop off the side into the river that is not edge protected. To protect guests from moving off the edge of the path into the water, a form of edge protection should be installed along the drop-off near the river. This may be accomplished by constructing a curb that is not lower than 4-inches high (**Level 3 recommendation**). Alternatively, the Overlook handrails may be extended along edge of

the drop-off (**Level 3 recommendation**). The Warren Eagle Troop Bench and Event Board is located over 48-inches from the side of the paved path on tall grass and soil. Guests with assistive technology may not be able to access these elements. To make this feature accessible, the bench and event board may be moved to be directly adjacent to the paved path (**Level 2 recommendation**). A final note regarding the Roselle Park Trails is that the entire length of trails is a considerable distance. There are benches present along the trails that can function as respite areas. However these fixtures are spaced far apart, particularly along the paths in the area north of the Wetlands Restoration. Additionally, many of the paths do not have companion pads at the sides of the benches. To comply with the ADA, these spaces should have a firm stable surface for an assistive device to pull off of the path that measures at least 32-inches wide by 48-inches long (**Level 3 recommendation**). The Prins Memorial Benches along the river are located over 60-inches from the paved path. This may be a barrier to guests with assistive technology that cannot cross turf and soil safely. To make the benches accessible, an asphalt or concrete path and pad should be constructed to connect the bench space and the paved paths (**Level 3 recommendation**), or the benches should be moved to be directly adjacent to the paved path (**Level 2 recommendation**).

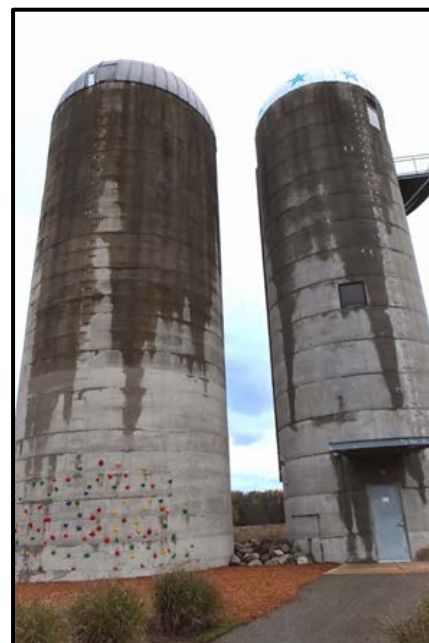
- **The Silo Observation Tower:** Observation Tower has a live camera feed for people who may not be able to access the viewing platform of the structure by the stairs. The viewing monitor is on the ground level. However, the camera is currently disconnected due to maintenance difficulties. In the past, the camera on the viewing platform has experienced malfunctions due to weather and repairing device was costly. The park was unable to continue offering the use of the camera to the guests. To ensure that guests with assistive technology are able

to experience the parks attractions in an as equivalent a manner as possible, the camera functionality should be restored (**Level 2 recommendation**). However, in order to avoid the difficulties that were encountered in the past, the camera may be moved so as to be sheltered from the elements and inclement weather. This may be accomplished by placing the camera under an overhang (**Level 2 recommendation**). Alternatively, the camera may be placed in the Silo interior and face out the windows. Care should be taken to ensure that the images from the camera are clear if this option is pursued (**Level 2 recommendation**). The camera may be configured to be only operable when needed, instead of being active all the time. If a guest would need the use of the camera, the guest may be able to turn on the device, and turn the camera and monitor off when finished (**Level 2 recommendation**). The ground floor has poor illumination. Improved Lighting should be integrated to ensure that people with visual impairments are able to navigate the area (**Level 2 recommendation**). There is currently no seating options on the ground floor. This may present a barrier for guests with limited stamina or strength, but do not use a wheelchair or scooter. At least one (1) seat should be placed on the ground floor for people who are using the viewing monitor (**Level 1 recommendation**). There is an accessible-style picnic table located outside the silo entrance. However, this element is on turf and soil, which may be a barrier to people with assistive technology. The accessible-style picnic table should be moved so that the accessible station is directly adjacent to a stable, level floor surface.
